PROJECT SHEET

ENVIRONMENTAL PROTECTION WORKS
CHANNEL DEEPENING PROJECT, MELBOURNE, AUSTRALIA

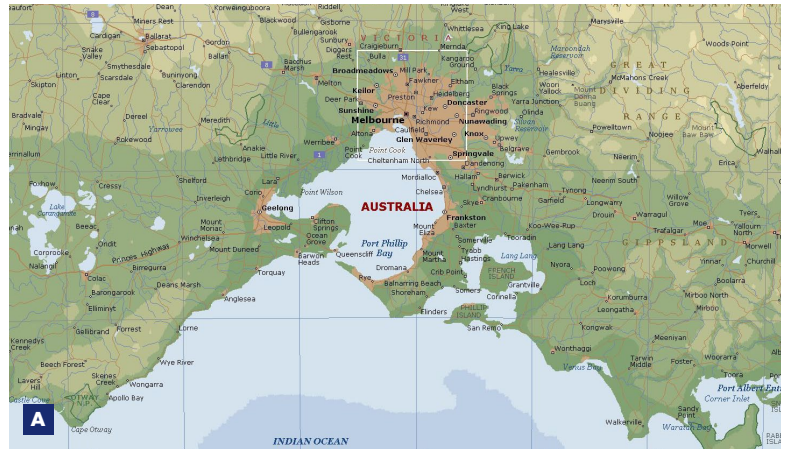
- A** Location map
- B** Monitoring buoy in Port Phillip Bay
- C** Seals in the South Channel in Melbourne, with the TSHD Queen of the Netherlands sailing by

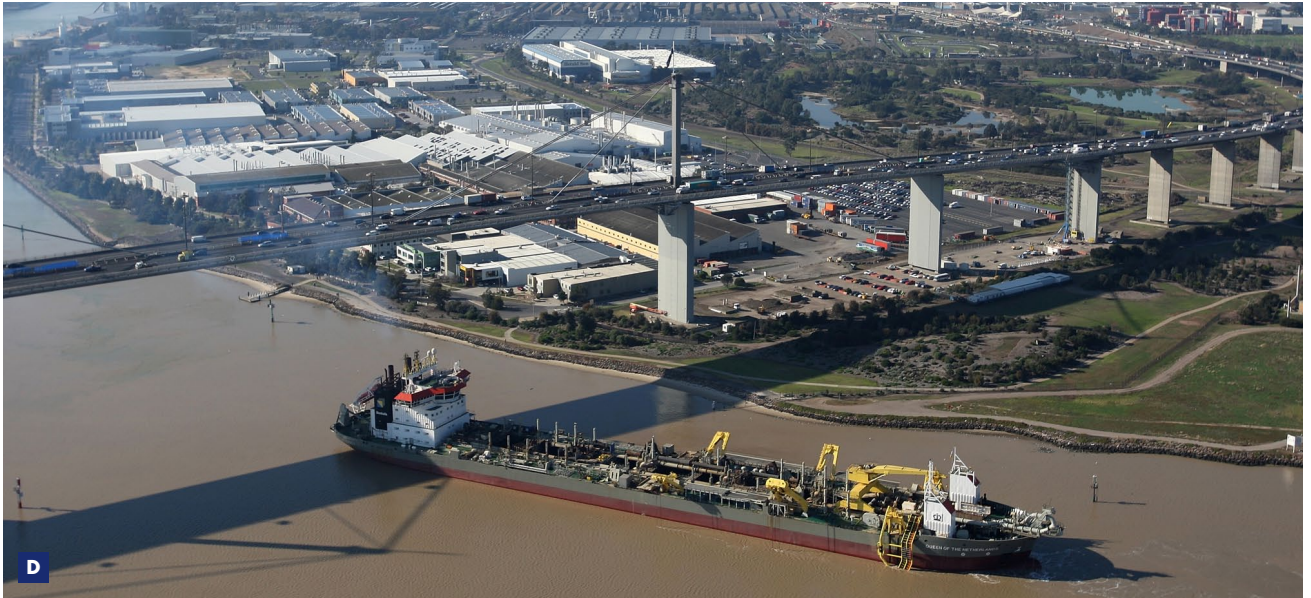
- D** Boskalis' TSHD 'Queen of the Netherlands' in Melbourne. With its capacity of 35,500 m³, this is one of the largest Trailer Suction Hopper Dredgers in the world
- E** Project outline
- F** Monitoring vessel with streamer

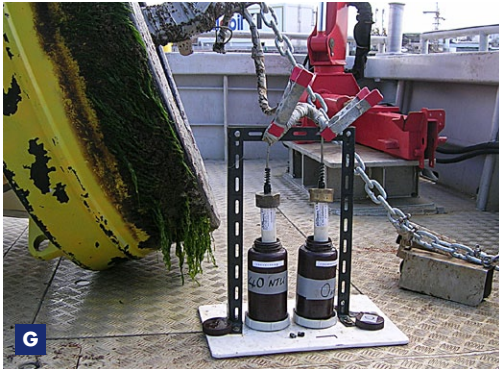
G Verification of sensors

During the SEES, a turbidity dispersion model was calibrated based on measurements determined during the earlier 8-week dredging trial and provided realistic environmental turbidity limits. Boskalis managed the turbidity measurements using a system of 22 buoys, which tested the seawater every 12 seconds. These were used to check compliance at 11 locations as well as to support further reporting purposes such as background values. Turbidity was monitored for up to 585 days. Weekly maintenance of the buoys was required to cope with the bio-fouling of the sensors. Verification of the sensors

in standard solutions was applied monthly. Approximately 2 buoy replacements were carried out on average every week. A high level of redundancy was created by using 2 independent sensors per buoy and by doubling the computer system at the office. Over 99.98% of data capture was achieved during the approximately 300,000 service hours of the 22 buoys.

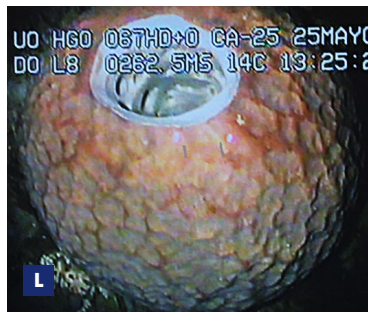
- J** Sand-silt interface of capped silt
- K** Removing seaweed
- L** Sponges of approximately 60cm at 65m water depth
- M** Sponges of approximately 53m water depth.
- N** Nepean Bank after clean up
- O** Disposal area after capping with sand
- P** Nepean Bank kelp re-growth
- Q** Nepean Bank re-growth algae

The TSHD Cornelis Zanen then dredged the contaminated silt. Extensive survey efforts were required to prove that 100% of the silt had been removed. The Grab Dredger Goomai removed the silt inaccessible to the TSHD. The dredged silt was then discharged through a Boskalis-patented diffuser into the disposal area at planned positions. No mixing with the ambient water occurred, no dredged silt was found outside the disposal area and water quality was not affected. A 12m wide spreader was developed for the Queen of the Netherlands to place a 0.5-m sand cap in subsequent thin layers over the deposited contaminated silt. The deposited silt stayed in place and the individual sand layers did not cause the silt to become unstable. Tube samples taken after completion of the cap revealed a sharp interface between the silt and capping sand on top.
