# PROJECT SHEET

**PORT OF WALVIS BAY, NAMIBIA**  
DREDGING AN ENTRANCE CHANNEL IN AN ECOLOGICALLY HIGHLY SENSITIVE AREA

## INTRODUCTION

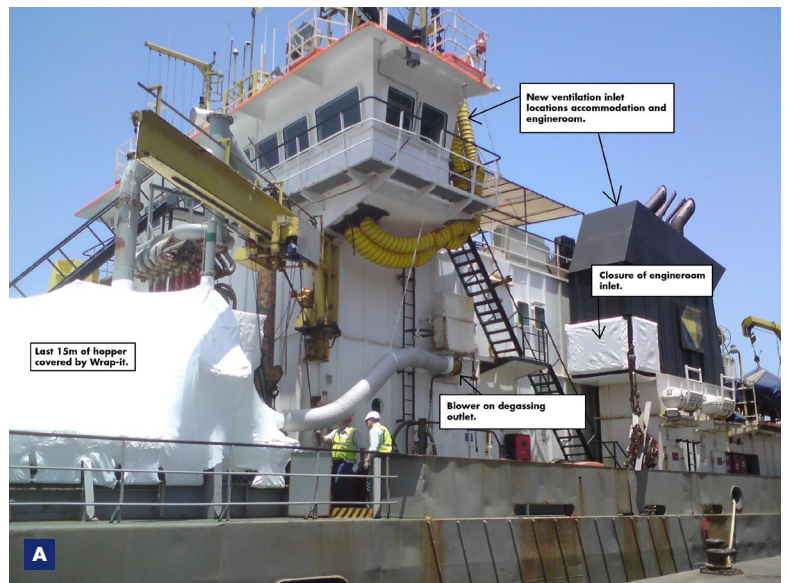
- A** To ensure problem-free dredging, the TSHD Argonaut was modified by installing equipment including a degassing system and accommodation filter units
- B** TSHD Cornelis Zanen joined halfway through the project

Throughout the dredging area, H<sub>2</sub>S was present, sometimes in extremely unpredictable high concentrations. Both vessels therefore required modifications to dredge without problems, and they were fitted out with a degassing system and accommodation filter units. A measurement system was installed to monitor the flow of gas on board. In the most extreme situation, high gas concentrations of more than 7500ppm were measured. However, the extensive preparations showed that H<sub>2</sub>S gas can be controlled satisfactorily. With the precautionary measures in place, it was possible to keep the level to 0ppm in the accommodation at all times and there were no major technical delays due to the gas during the dredging.

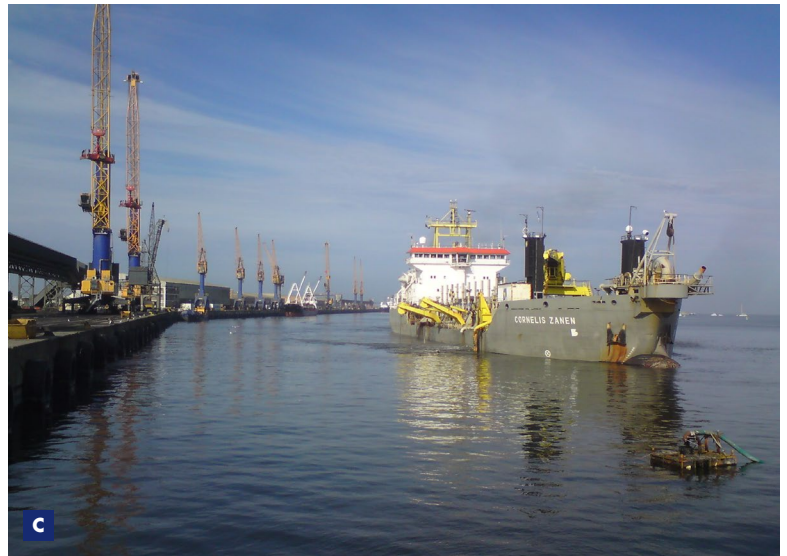
**C** TSHD Cornelis Zanen dredging near the quay wall on the site
