# PROJECT SHEET

## RISER REPLACEMENT/REPAIR

INSPECTION, REPAIR, MAINTENANCE & LIGHT CONSTRUCTION  
DUBAI, UNITED ARAB EMIRATES

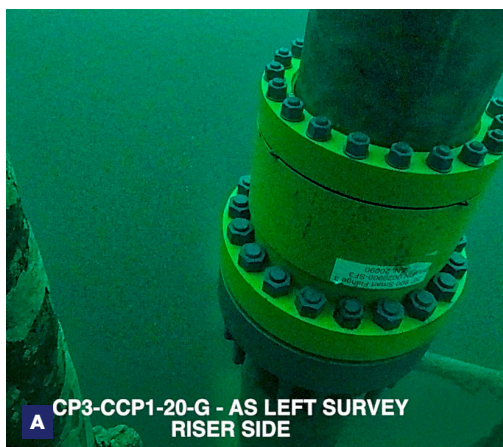
On the 5<sup>th</sup> May 2016 client identified a leak on a 20 inch transfer high pressure gas pipeline, upon confirmation Boskalis investigated the leak location. The results of the leak investigation confirmed a gas leak which was observed on the 4 inch piggy back riser coming of the main 20 inch gas transfer pipeline at EL(-)139 ft. Gas was seen escaping from the circumferential weld closest to the main weldlet connection.

- A 4" piggy back injection line leak coming off main 20" gas transfer pipeline
- B CCP1
- C Deployment of the new 20" gas transfer riser bend section

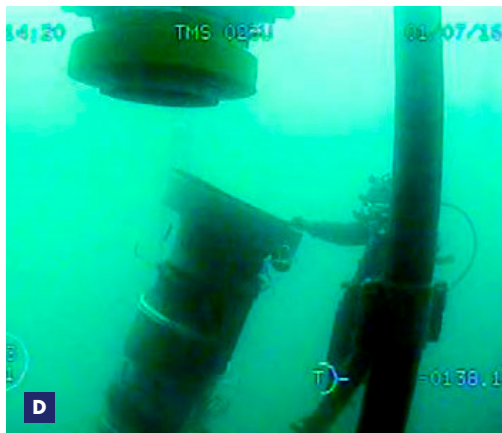
- D** Installation, positioning and alignment of the new 20" gas transfer bend section into the 20" smart flange
- E** As built video survey during pressure test verifying the close proximity of the surrounding risers to the vertical smart flange connection
- F** As built 3D image of repaired 20" gas transfer bend section
